# **THE CALIFORNIA EARTHQUAKE OF 1906**

The  
California Earthquake  
of 1906

*Edited by*  
David Starr Jordan

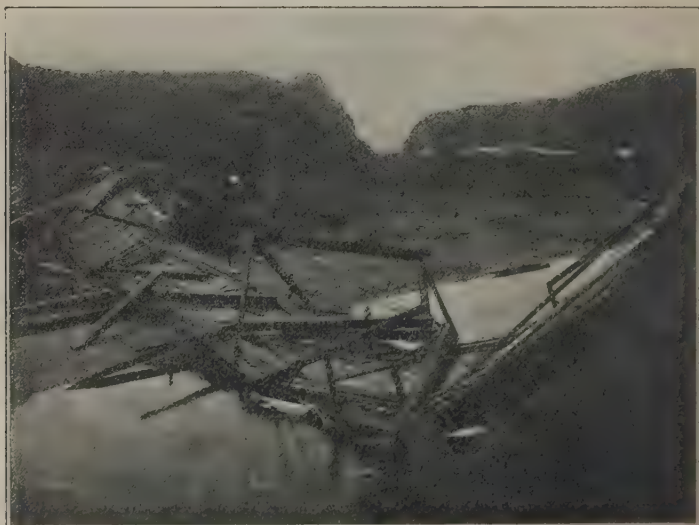
*Alder Creek Bridge, Mendocino County. The Earthquake Rift Is near the Middle of the Picture.*

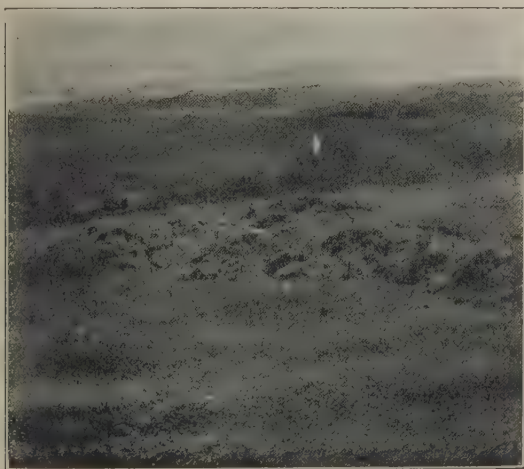
*Earthquake Rift, Freeman's Ranch, near Tomales Bay.*

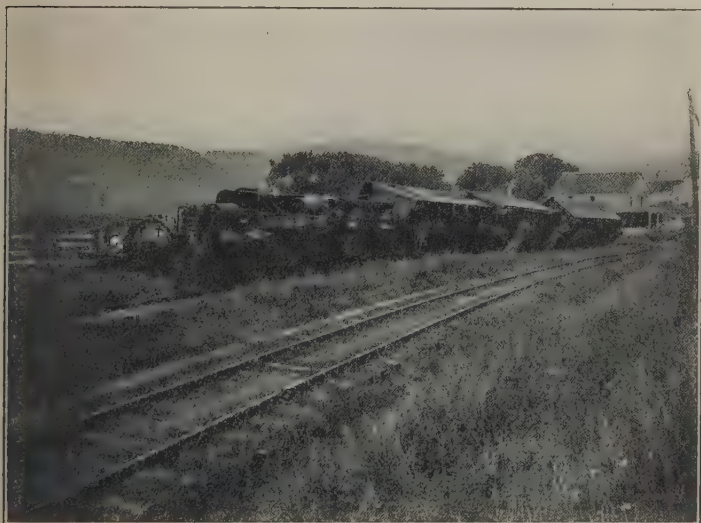
*Train Overturned by Earthquake, Point Reyes Station, Marin County, Cal.*

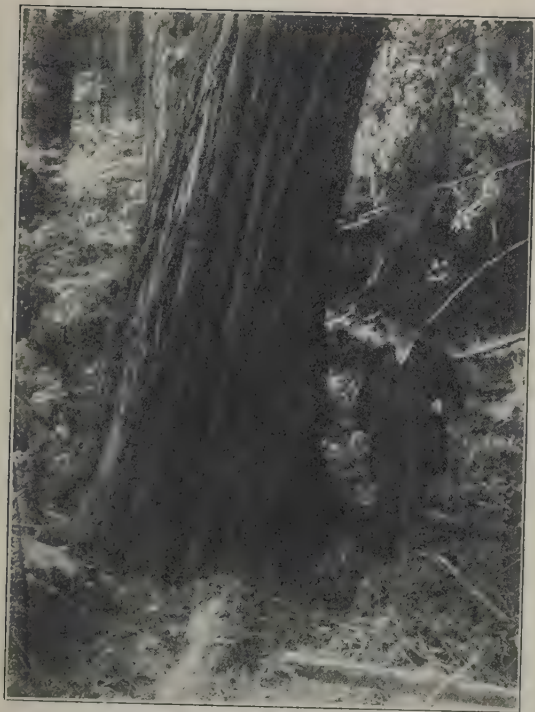
FIG. 3.—Redwood Tree, Situated on the Fault Line, near Fort Ross,  
Sonoma County, California.

sides of the fault, which explains the cracking at the base of its trunk. Many trees were more or less ruptured along the fault where the line traverses timber growths; and in one place I observed leaning redwood trees for a con-

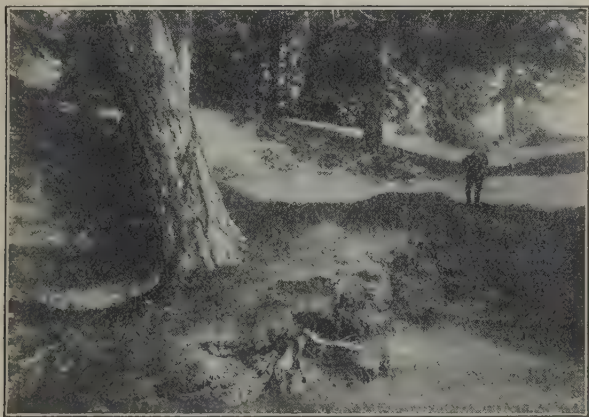
FIG. 4—Pine Tree Standing on the Line of Fault near Fort Ross, Sonoma County; the Ruptured Surface Shows the Characteristic Appearance of Newly Plowed Ground.

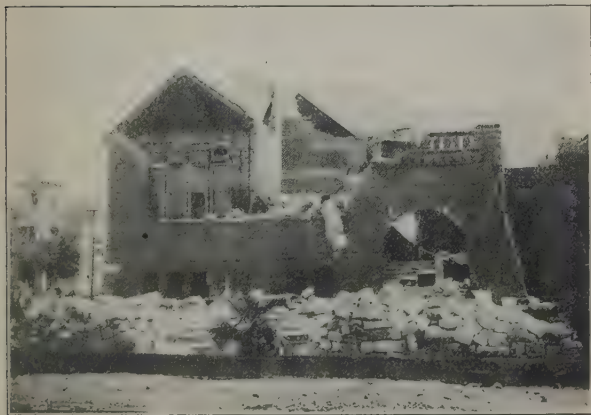
FIG. 8—Carnegie Library, Santa Rosa. A Typical Brick Building with Wooden Interior Framing; the Outer Walls Faced with Cut Stone. Buildings of This Type of Construction Invariably Were Shattered near the Roof Lines. The Picture Is Representative of the Behavior of Stone-faced Buildings with Inadequate Wood Framing.

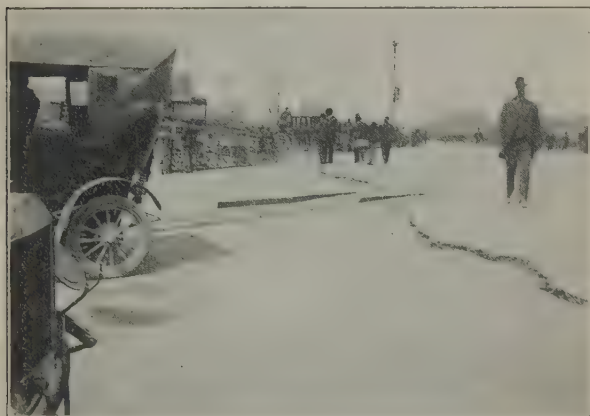
FIG. 11—*Street Surface in Front of the Ferry Tower, Showing Undulations and Cracks in the Asphalt Pavement.*

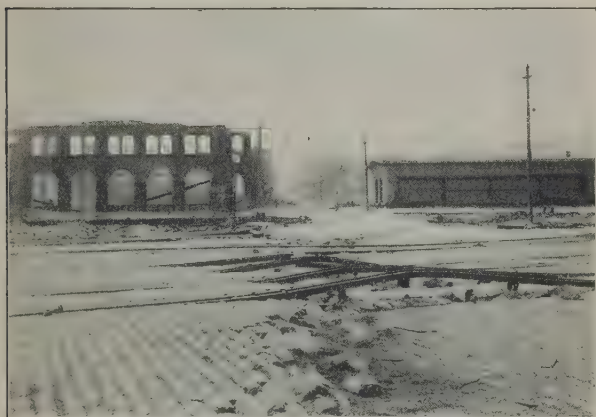
FIG. 12—Rupture of Car Tracks and Pavement on East Street,  
Corner of Pacific Street.

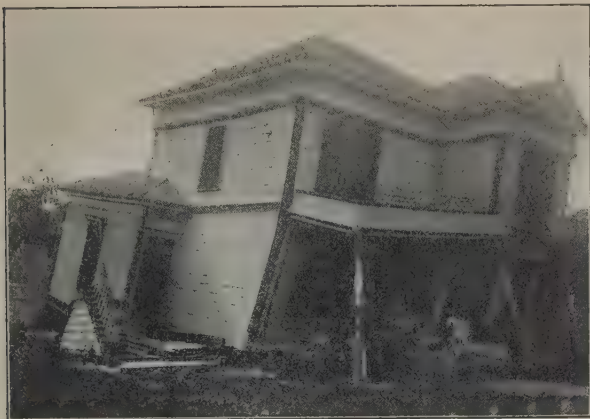
FIG. 15—Frame House Wrecked in Santa Rosa; Due to Weak and Decayed Underpinning.

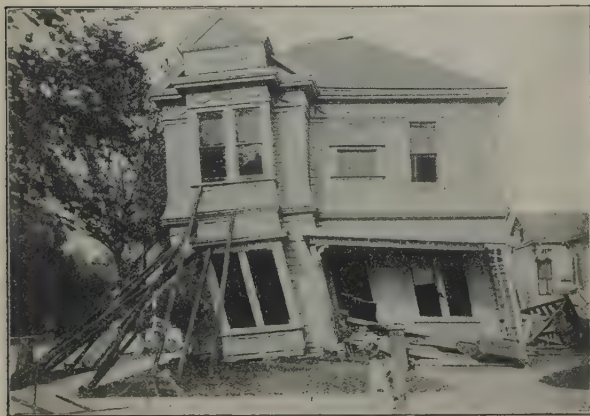
FIG. 16—Collapsed Frame House in San José Showing the Effect of a Lack of Transverse Framing and an Absence of Continuity in the Vertical Sticks at the Floor Levels.

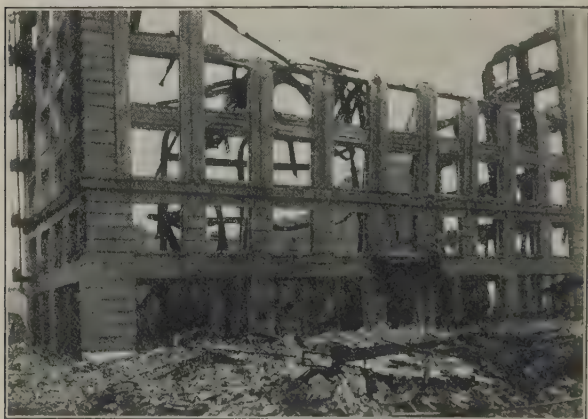
FIG. 22—*Fire Ruins of the Cowell Building, a Class B Structure, Showing the Great Destruction by Fire.*

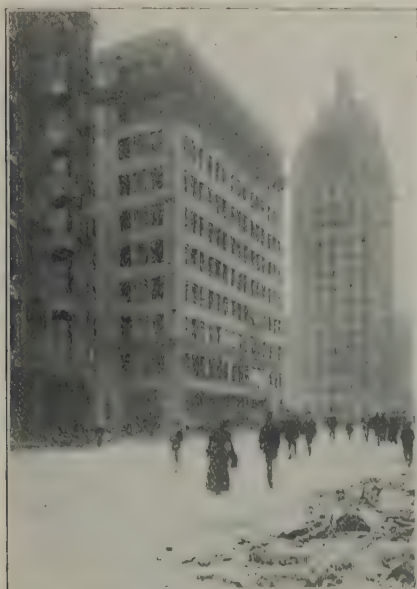
ing was observed at a corner of a building, see Fig. 23. Such destruction is not so serious in Class A buildings as in those designated Class B,

*FIG. 23—The Monadnock Building, Showing Heavy Diagonal Cracks in the Brick Curtain Walls along the Northeast Corner for the Full Height of the Structure.*

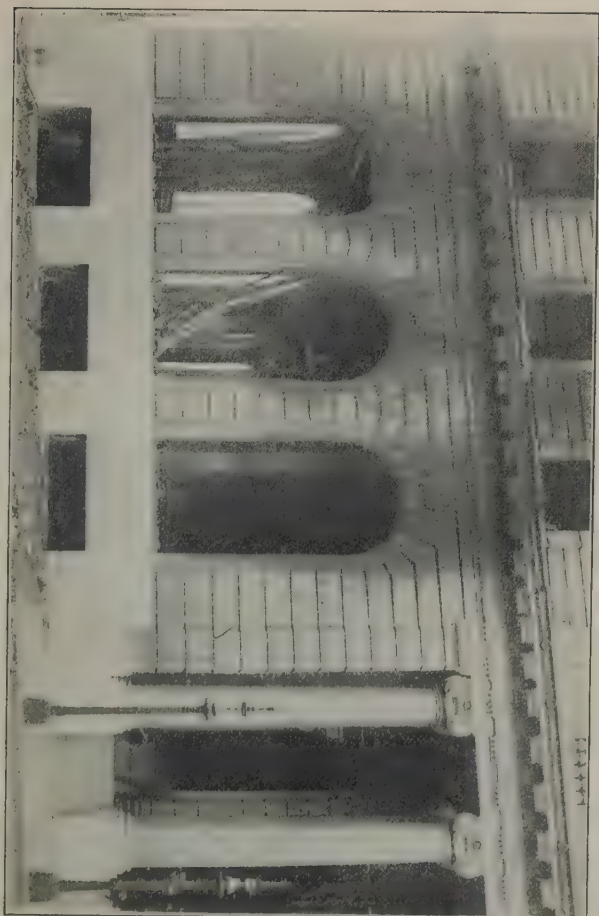
FIG. 25.—St. Francis Hotel, Southeast Corner, Showing Heavy Earthquake Cracks in the First Story of the Sandstone Front.

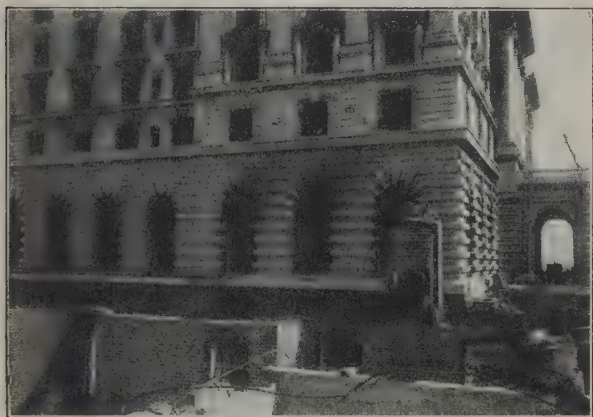
FIG. 26—Fairmont Hotel; North Front, Showing Earthquake Cracks in the Terra-Cotta Veneer of the Second Story Walls.

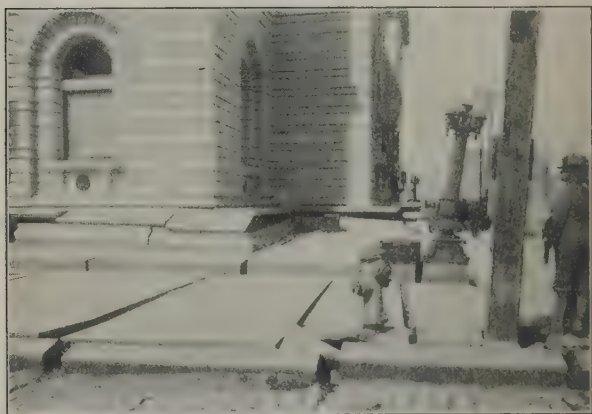
FIG. 27—General Postoffice, Southwest Corner, Showing Severe Distortion and Subsidence of the Sidewalk and Street Levels.

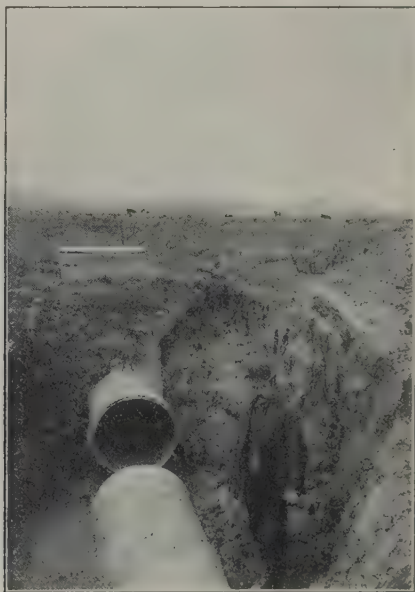
FIG. 34—Rupture on Pilarcitos Pipe Line near North End of San Andreas Reservoir.

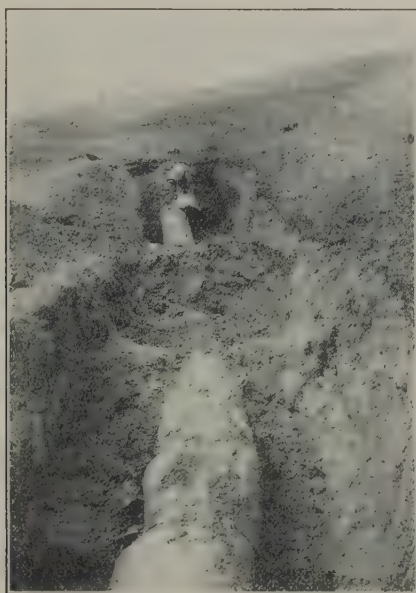
FIG. 37—*Diagonal Ruptures, Pilarcitos Pipe Line, Spring Valley Water Company.*

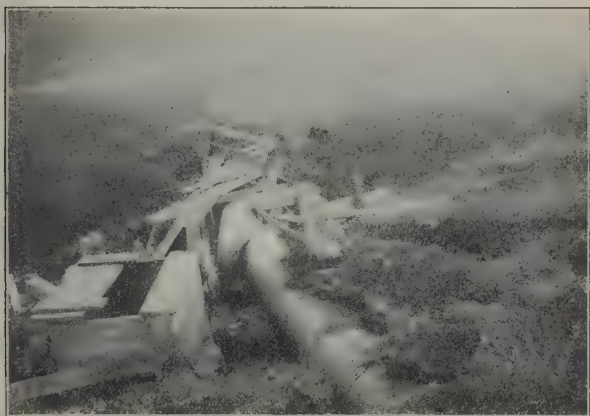
FIG. 39—*Collapse by Compression at a Small Trestle, Pilarcitos Pipe Line, Spring Valley Water Company.*

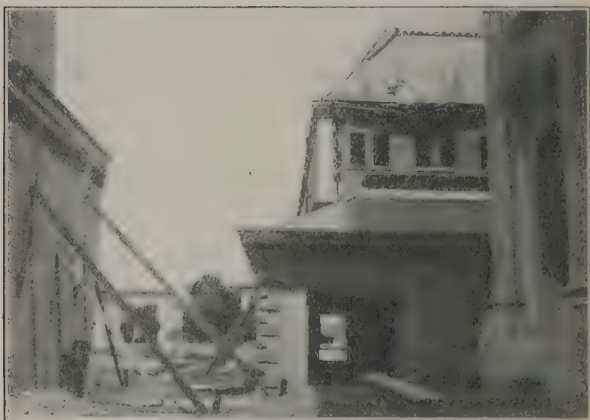
FIG. 48—Rear View, Hall of Records, San José, Showing How the Heavy Stone Outer Walls Cracked Away from the Interior Framing Due to Improper Anchoring of Walls to Floors and Roof.

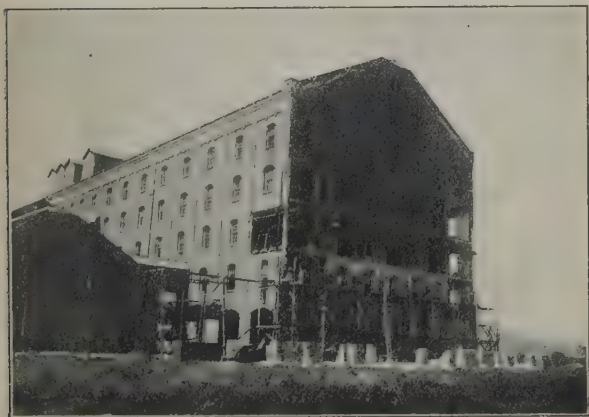
FIG. 54—North Wall, the Spreckels Sugar Mill, near Salinas, Showing Ruptured Brick Curtain Walls and the Advantages of a Class A Steel Frame.

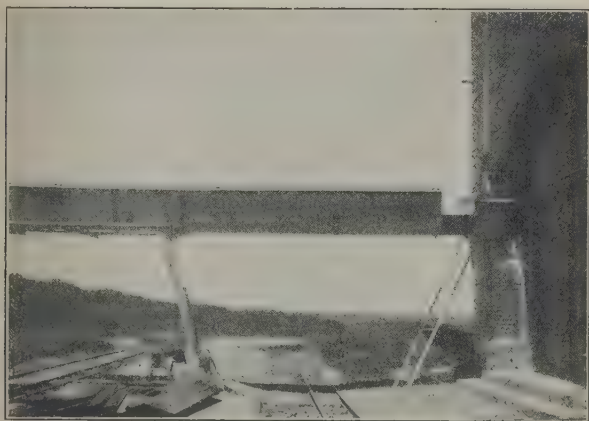
*FIG. 55—Ruptured Conveyor, the Spreckels Sugar Mill, near Salinas,  
Showing Slipping of the Ground into the River.*

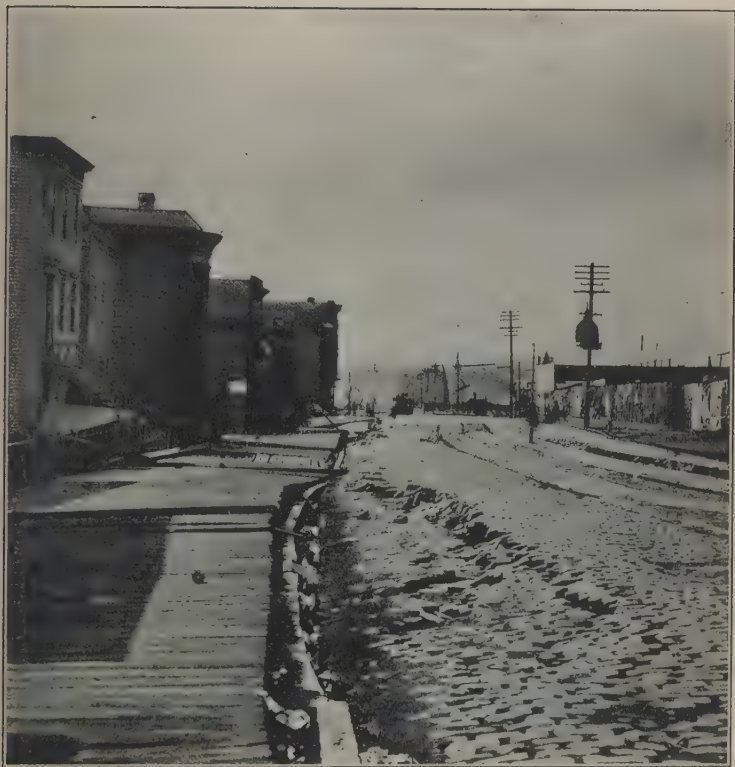
FIG. 9.—Street Scene in San Francisco, Showing Effect of the Earthquake on Filled Ground.—The Distant Part of the Street Probably Retains Its Original Level and Position. Nearer by the Ground Has Settled Several Feet and Has Also Moved to the Left.

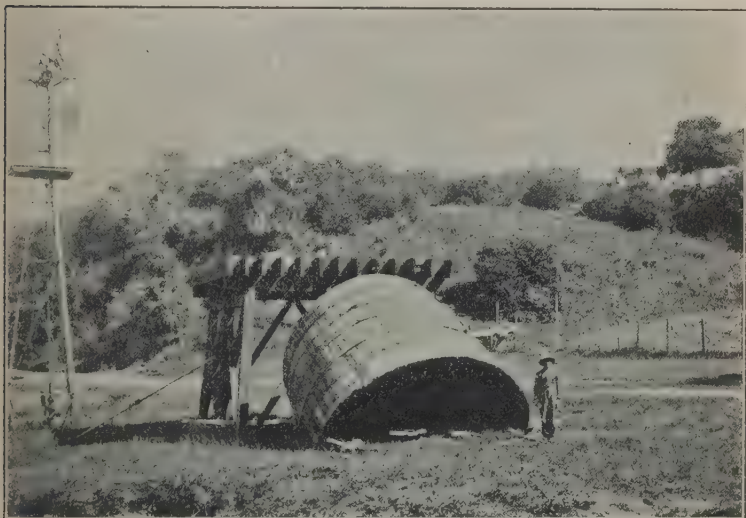
FIG. 12—*Water Tank Thrown from Its Pedestal by the Earthquake.*

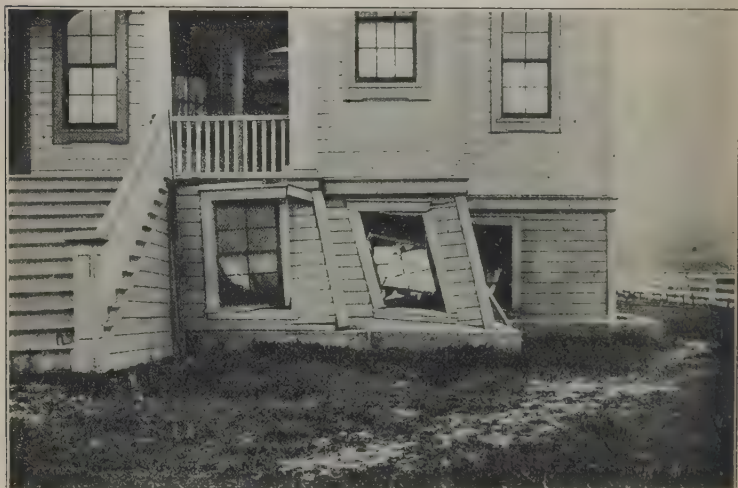
FIG. 13—School-House at Point Reyes Station, Near Inverness; Shifted Horizontally Two and One-Half Feet by the Earthquake. The Corner Here Shown Was Slipped from the Foundation and Rests Directly on the Ground.

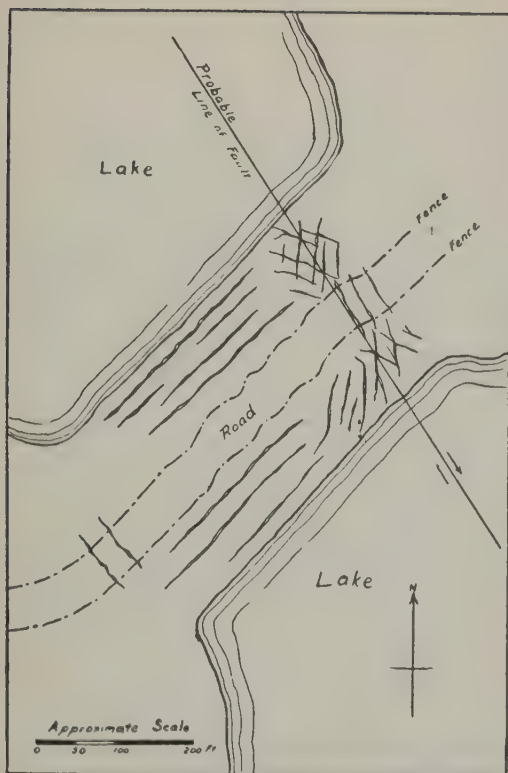
FIG. 7—Dam at Crystal Springs Lake, Showing Cracks Formed by the Displacement.

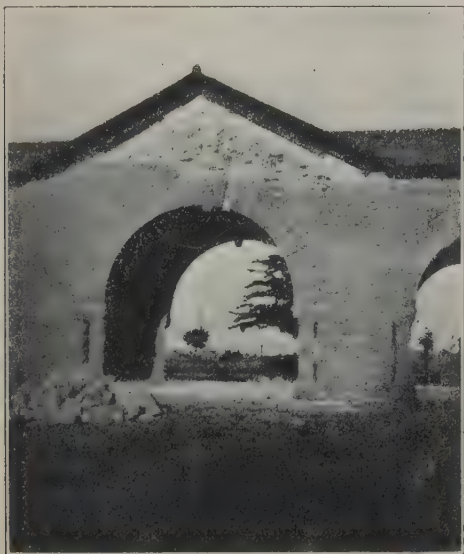
FIG. 9—*Photograph of Arches at Stanford University, Showing Keystones Lowered During the Earthquake. These Arches Were Nearly at Right Angles to the Fault-Line.*

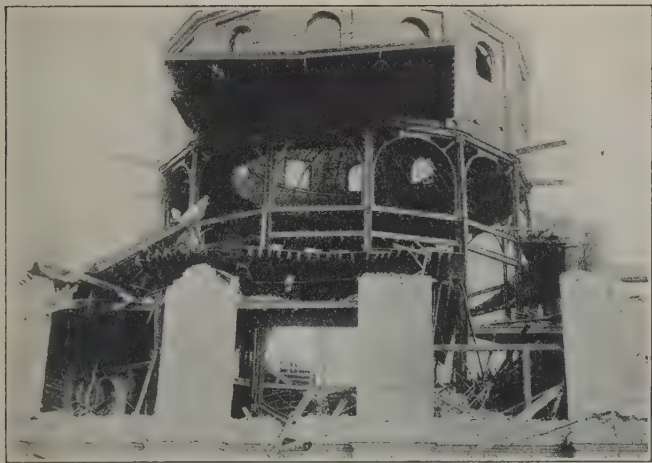
FIG. 15—The Damaged Condition of the Newly Erected Library of the Stanford University. The Central Steel Dome Behaved as an Elastic Inverted Pendulum.

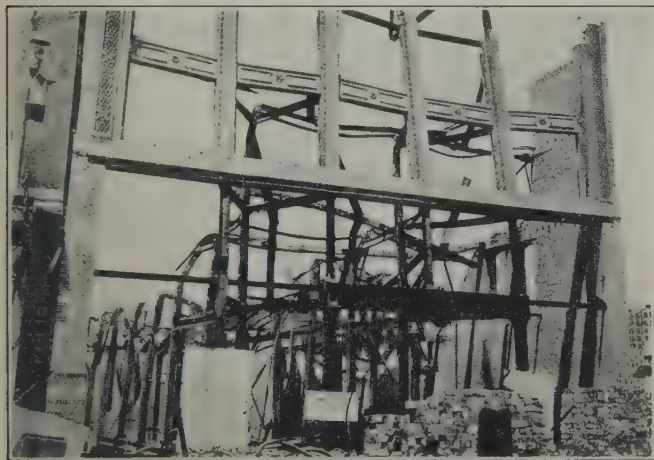
FIG. 16—The Ruined Condition of a Steel-Framed Brick House in San Francisco, Which Was Dynamited and Then Burnt, Showing the Remarkable Effects of the Intense Heat.

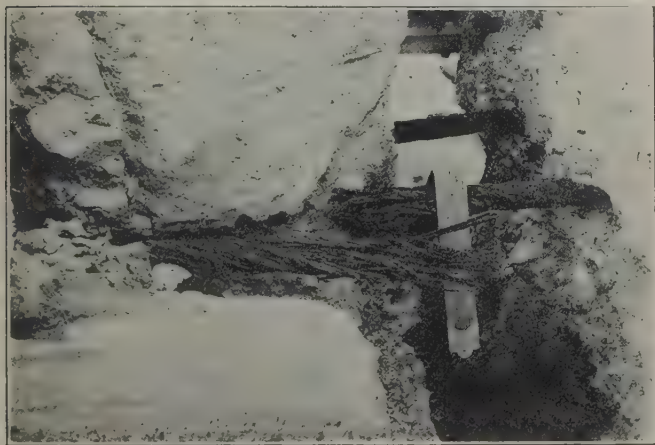
FIG. 18—One of the Cracks of the Basement Wall. The Steel Cable, One Inch in Diameter, Which Was Embedded in the Concrete, Was Broken.
